**Natural Resources Inventory for the Area of Cobbs Creek Park Between the
SEPTA Train Bridge and Florence Avenue, Including
the Two Meadows Flanking Whitby Avenue/Longacre Boulevard**

12-Mar-2021

Prepared by Land Health Institute

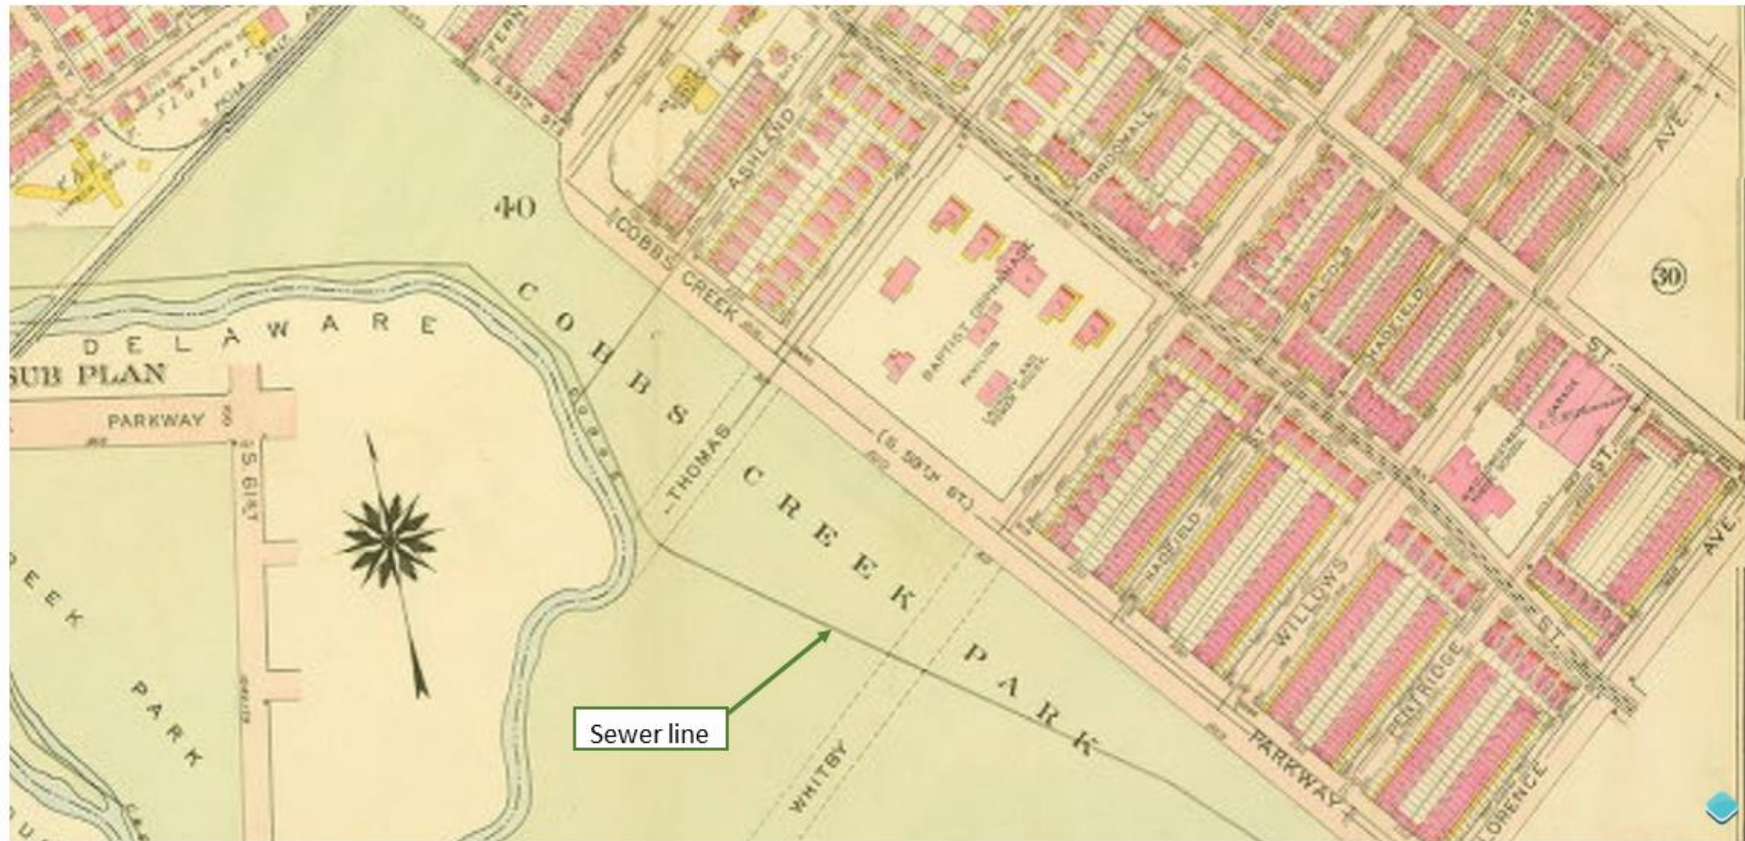
Figure 3: Historic Map From 1927

Historic map of Cobbs Creek area showing proposed extensions of Whitby and Thomas Avenues through/into the park and sewer line.

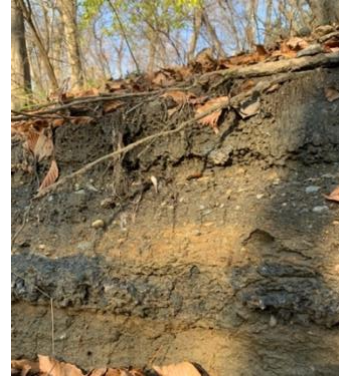
Urban soil profile, including a layer of asphalt

From a soil profile perspective, our analysis suggests that the C and B horizons of the soil profile are generally well established throughout the site. In contrast, A and O (organic) horizons are generally poorly developed. Several factors contribute to the poor accumulation of organic matter in the upper layers of the soil profile. For example, sheet flow of stormwater coursing over the steep slopes of the site tends to quickly erode most newly forming topsoil. Over-abundant white-tailed deer cause both soil compaction in areas of flatter terrain and erosion in steeper areas. Further, Asian earthworm activity is pronounced throughout the site, thereby negatively impacting soil chemistry and soil structure at the top of the soil profile.

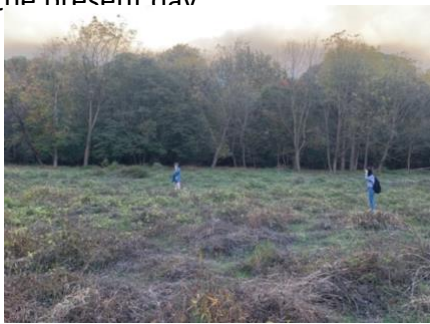
*Poorly established native plant growth
in Yeadon meadow*

Presumably due to regular applications of broadleaf herbicide over the years, native forbs are essentially absent from both meadows. Some patches of white snakeroot (*Ageratina altissima*) and hyssop-leaved thoroughwort (*Eupatorium hyssopifolium*) are present in the meadow. One small patch of common milkweed (*Asclepias syriaca*) was observed in the Yeadon meadow. In some edge areas of the meadows, invasive vines, including Japanese hops (*Humulus japonicus*),

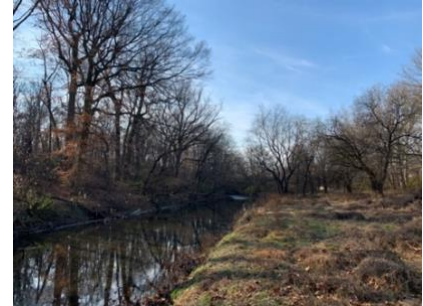
Throughout most of the project area, established forested areas adjacent to or near Cobbs Creek are generally spotty or absent. Below the Whitby Ave. bridge, on both sides of the creek, Japanese knotweed (*Polygonum cuspidatum*) is well established in several streambank areas. In the areas between the lower parts of each meadow and the creek, Japanese stiltgrass grows robustly. On the Philadelphia side of the creek above Whitby Ave, riparian vegetation is very limited due to the proximity of the footpath to the creek. Consistent with the sparse riparian vegetation and correspondingly sparse root mass, streambank erosion is pronounced in many places.

Sparse woody vegetation in the floodplain

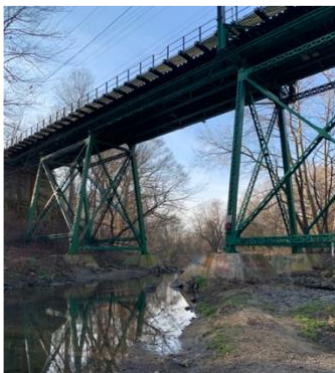
SEPTA bridge, piers anchored in Cobbs Creek

Several piers supporting the SEPTA train bridge that spans the Cobbs Creek corridor are located both directly within the stream itself and upon its banks. Bridge abutments located on either high point of the stream valley also support the bridge. Downstream of the bridge, streambank erosion is substantial. This erosion is directly caused by high-volume, high-velocity streamflow during storm events. Below the bridge on the Yeadon side, banks are marked by severe gradient. Mass wasting of the banks, which contain minimal established root mass, is continual. Debris carried by streamflow during storm events, notably plastic bags and other plastic litter, is abundant in tree branches and on streamsides. Erosion in the riparian areas on both sides of the stream can also be observed in the form of drainage gullies formed by runoff emanating from stormwater that drains from or is diverted around the bridge abutments.

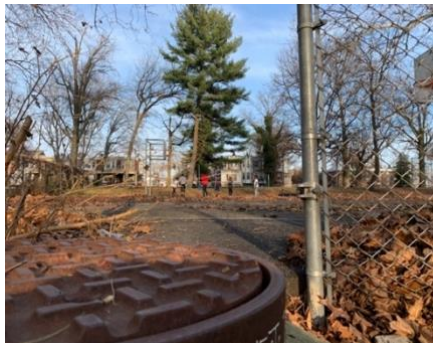
The surface hydrology of the study site is driven by a combination of factors, including topography, surface material covering the ground plain on or adjacent to the site, and alterations made to the natural land or stream areas of the site. Due to the generally steep-sloped nature of the study site, velocity of stormwater sheet flow during storm events tends to be high in many areas. This factor, combined with the general paucity of vegetative ground cover, leads to continual sediment erosion from many of the steep areas on the site. Drainage from Cobbs Creek Parkway and the Whitby/Longacre road is causing ongoing erosion in various spots. Points of hydrologic stress are the basketball courts and playground areas draining into the forested areas of Cobbs Creek Park on the Philadelphia side of the study area. On the Yeadon side, suburban backyards border the natural area and contribute concentrated runoff in several spots.

One source of runoff

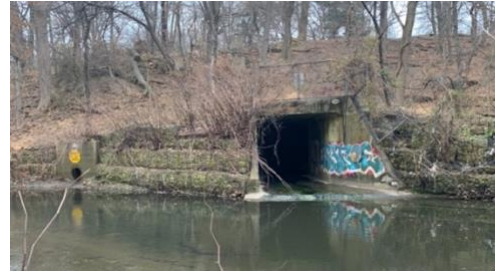
CSO outfalls C16 (on left) and CFRTR (large rectangular opening)

Between the SEPTA bridge and Whitby Ave. is a very large Philadelphia Water Department CSO outfall structure labeled CFRTR; connected to that structure is a small outfall pipe labeled C16. This overall structure occupies a large section of streambank on the Philadelphia side of the creek. Gabion baskets have been placed adjacent to this massive structure to help stabilize the structure and the adjacent streambank. Streambank erosion downstream of C16 and CFRTR is significant, comparable to the erosion caused by the SEPTA bridge piers. To help limit erosion on the Yeadon side of the creek, gabion baskets have been built into the streambank there. While some erosion is prevented by the gabions, erosion is evident around and behind them. The erosion precipitated by CFRTR is two-fold. First, the structure itself acts as a hard barrier that confines the stream and reroutes its flow, which scours out soil on the opposite bank. Second, during sizable storm events, high volumes of combined sewer overflow water, mixed with raw sewage, rushes from the outfall pipe at high velocities, thereby causing significant erosion. Debris, largely plastic, contained within the overflow discharge water becomes stuck on branches and between rocks downstream of CFRTR.

Point sources of pollution along Cobbs Creek within the study area are the CSO discharge points noted above. During storm events that produce a certain threshold level of stormwater, that stormwater drains from city streets, carrying various pollutants, mixes with untreated raw sewage from nearby residences, and flows through city sewer pipes. This mixture eventually flows through outfalls directly into Cobbs Creek. Three CSO outfalls are located on the Philadelphia side of the creek within the study area, and one lies immediately beyond the study area. CFRTR and C16, just downstream of the SEPTA bridge, are described above. Based on numerous field visits, our observations, including that of a rich growth of algae at the base of the CFRTR outfall, suggest that water flows constantly from CFRTR. No detectable sewage odor was detected from this base flow during dry weather. Perhaps this base flow is groundwater flowing as an underground spring. During one site visit, an odor of laundry detergent was detected in the vicinity of CFRTR and C16.

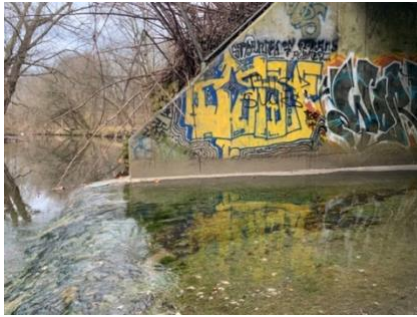
Base flow coming out of CFRTTR

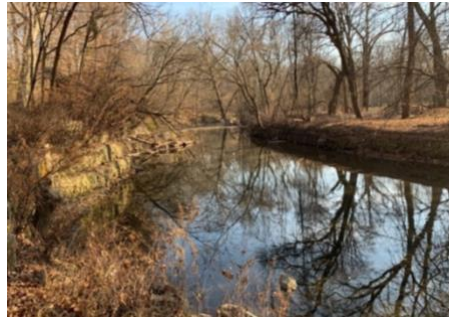
- deeply cut, highly eroded streambanks, largely denuded of vegetation;
- banks replaced, in places, by artificial gabion structures (wire frames containing rocks, or 'riprap'), causing channelized conditions;
- overly wide, overly shallow stream conditions, causing relatively slow flow areas, which are prone to low dissolved oxygen levels during hot weather conditions;
- persistent deposits of plastic debris and other litter, deposited during flash flood events and CSO discharge events.

Gabions hugging both banks; still water

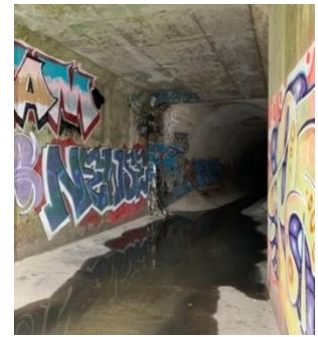
Looking into CFRTTR

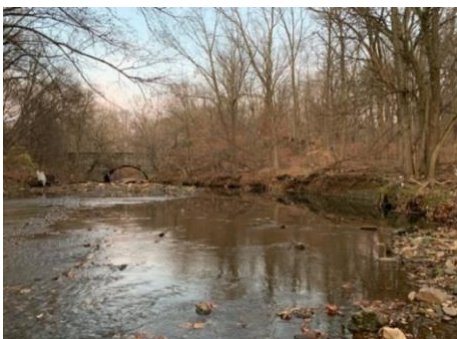
The segment of Cobbs Creek downstream of the Whitby Ave. bridge is also generally degraded in terms of ecological health and structural integrity, although one subsegment, described below, is both relatively structurally stable and ecologically healthier than the remainder of the creek within the study area.

Rocky island and streambank erosion downstream of Whitby Ave bridge

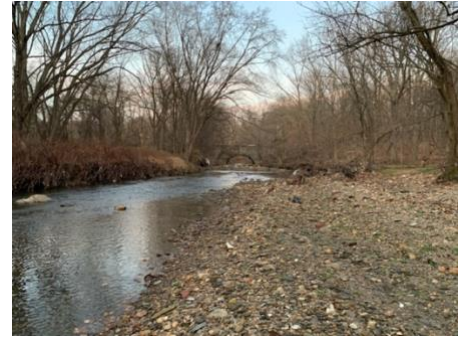
During storm events of a certain intensity, water flowing down Cobbs Creek is impeded by the opening of the Whitby Ave. bridge and backs up behind the bridge opening on the upstream side of the bridge. Eventually, the backed-up water flows through the bridge opening. When it does, it does so with increased force, intensity, and velocity compared with normal streamflow conditions. The orientation of the Whitby

Ave. bridge in relation to the channel of Cobbs Creek is such that the accelerated streamflow heads directly toward the streambank on the Philadelphia side of the stream, downstream of the bridge. The impact of the stormwater-charged streamflow on the land is severe. Erosion of the streambank around the center of impact is substantial. Overall, this section of streambank is in a perpetual state of mass wasting. Also, flood water passing through the Whitby Ave. bridge bottleneck often washes high above the top of the bank, into the patch of riparian forest there and, sometimes, onto the lower portion of the Philadelphia-side meadow. In its wake, the flashy flow leaves a pronounced trail of debris. On the Yeadon side, across the creek from this high impact/high erosion area, is a prominent zone of accretion, marked by a large mass of medium-sized rocky sediments.

Looking upstream from long point bar toward Whitby Ave bridge

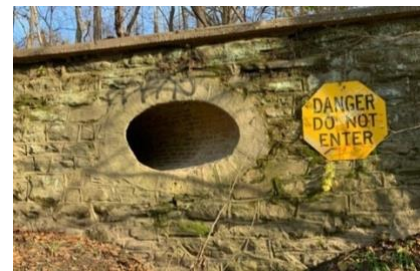
Between this dual discharge point and the Whitby Ave. bridge, a small (architecturally beautiful) oval-shaped, brick-and-stone outfall is built into the streambank. No label or CSO marking accompanies this outfall, although it is apparently active, as evidenced by a small amount of growth on rocks immediately below the mouth.

Elegant Outfall

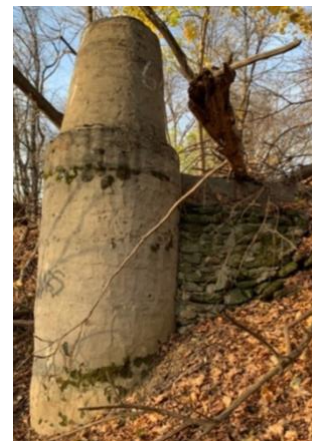
Sewer System: An active line of Philadelphia's combined sewer system parallels Cobbs Creek. Other active pipes, running beneath streets perpendicular to Cobbs Creek Parkway, intersect with this main line. The significant impacts of the discharges from the outfalls located within the study area have already been summarized. Throughout the study area, one frequently comes in contact with manholes, pipes, riprap, gabions, and other hard elements that are part of or associated with the sewer system. One noteworthy structure, located in the upland forest above CSO outfalls C16 and CFTR, is a large vertical manhole structure, approximately 20 feet tall. The presence of this tall structure suggests that plans to encapsulate Cobbs Creek in sewer piping and fill the stream valley to the height denoted by the manhole cover may have been in place prior to Cobbs Creek Park being permanently preserved and added to the Fairmount Park system early in the 20th century.

Old sewer indicating level to which stream valley could have been filled

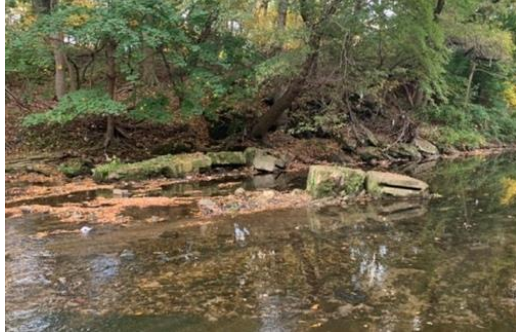
Site of former pedestrian bridge

structures are found on opposite sides of the creek. An old photograph supplied by Adam Levine shows a pedestrian bridge in this vicinity early in the 20th century. Hence, these structures may have once supported a pedestrian bridge over Cobbs Creek between Philadelphia and Yeadon.

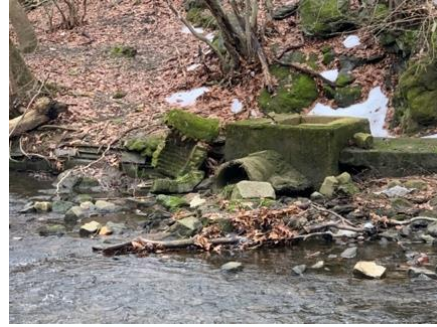
Structural remnants below the outcrop

- Not far downstream from the SEPTA bridge, a large concrete pad sits within the upland forest on the Philadelphia side, perhaps a relic of industry. Near the same area, a flat layer of asphalt can be detected within the soil profile, indicating that a paved road close to the creek once existed; part of this is now the footpath noted above.
- On the downstream end of the bend in the creek that wraps around the schist outcrop, remnants of stone support

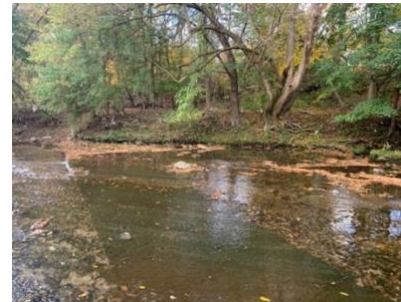
- Immediately downstream of these remnants is a flat, low dam-like structure that spans the creek.
- Three stone stairways exist on the Philadelphia side of the park, each still in relatively fine condition: one is adjacent to the northeast side of the Whitby Ave. bridge, leading to short woodland trails and, ultimately, the playground and athletic courts. Another is located close to the southwest corner of Cobbs Creek Parkway and Whitby Ave. A third

Dam-like structure near bridge ruins

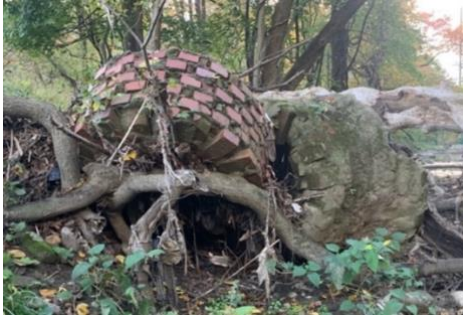
Old sewer structure on Yeadon side of creek

- Various brick, stone, and concrete remnants of an old, apparently non-functioning sewer system can be found on the Yeadon side.
- At the base of part of the schist outcrop area, remnants of a stone platform, likely a slate material, are visible.
- Large boulders, seemingly of a geological type different from the nearby exposed bedrock, sit in the park adjacent to Yeadon backyards, south of Longacre Blvd.

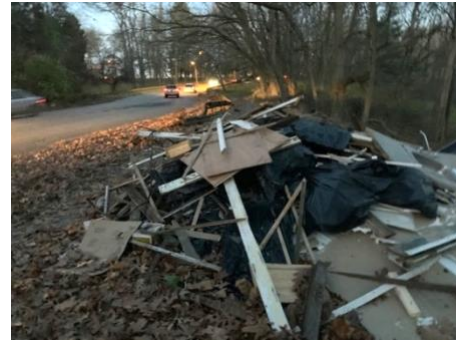
Short dumping of construction debris and other large materials is common at the park edges along Whitby Ave./Longacre Blvd. Typical materials observed in these areas include wallboard, windows, roofing materials, mattresses, appliances, furniture, plywood, plexiglass, plastics, and miscellaneous household goods.

According to discussions we have had with neighborhood residents and others with knowledge of this area, short dumping along Whitby Ave./Longacre Blvd. has been a problem for many years. We also observed construction and household debris dumped in back of the parking lot adjacent to the athletic courts, just above a steep slope leading down to the Creek.

Short dumping along Whitby Ave.

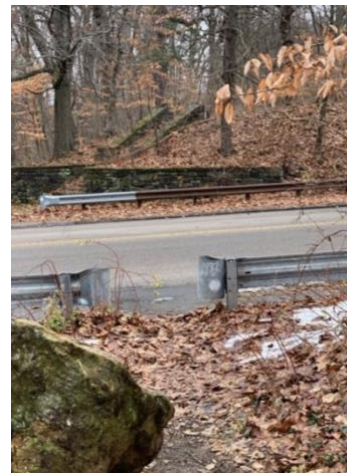
In a fully implemented trail plan, such as the one we propose, the major impediment is the roadway of Whitby Ave, which serves as a barrier to walkers and hikers making their way north or south in the park. We strongly recommend that a feasibility study of the relevant area be undertaken to support the creation of a safe pedestrian crossing of the Whitby Ave. within the park. The ideal location for such a crossing would be where the two footpath segments end at Whitby Ave, across from one another. While the posted speed limit there is 25 MPH, motorists frequently greatly exceed the speed limit. Also, a relatively blind curve is located on the east (Philadelphia) side of the proposed pedestrian crossing. The ideal solution would be a pedestrian bridge over Whitby Ave. In the absence of such a safe crossing, we recommend that both professionals and neighborhood residents consider a solution that includes speed bumps, stop signs, flashing caution lights, and posted speed calming signs on both ends of the Whitby/Longacre road. Included in the planning group should also be members of the Philadelphia and Yeadon Police Departments, neither of which, apparently, enforce the speed limit. At the time of this report's preparation, Rob Armstrong, Trails and Transportation Program Manager for the City of Philadelphia, had observed this area and committed to looking into this problem further.

Whitby Ave bisecting the footpath; study area for a pedestrian crossing

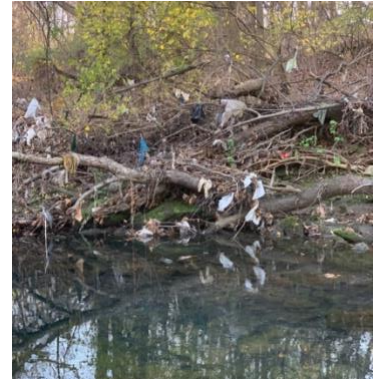
Debris below SEPTA bridge
